# Rapid structural relining secures Rio Tinto mining infrastructure

A corrugated steel pipe culvert required urgent structural rehabilitation to take the entire live load from the failing host pipe.

GeoCast (Geopolymer Mortar) structural relining.

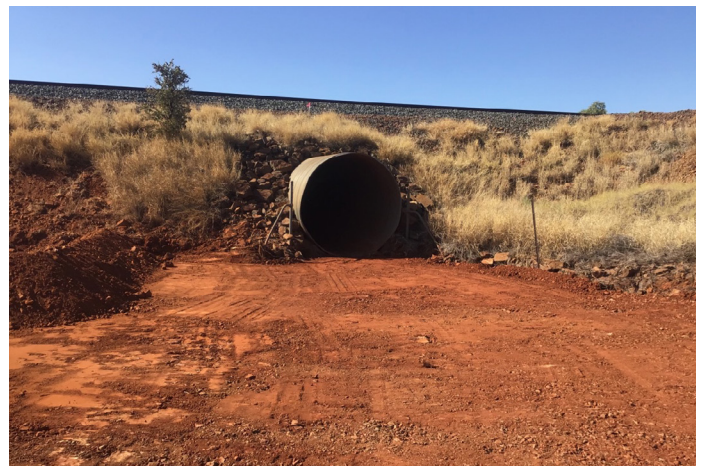
Ironstone Civil, on behalf of Rio Tinto, identified an urgent requirement to rehabilitate a failing corrugated steel pipe (CSP) culvert in a remote and operationally critical location. The solution needed to be more than just a repair; it required an engineered system capable of fully replacing the structural function of the host pipe and carrying all live loads. The project demanded rapid mobilisation and a proven system that could be installed efficiently without disrupting the asset's vital operations.

Hychem's GeoCast, a high-performance, fibre-reinforced geopolymer mortar, was specified for the structural relining. A material thickness was precisely engineer-designed to ensure the new liner could independently carry all structural loads, effectively creating a new, high-strength pipe within the old one. After thorough cleaning and preparation of the host pipe, including the installation of mesh to reinforce damaged sections, the GeoCast material was applied using advanced spin-casting equipment to create a seamless, monolithic, and structurally independent new culvert.
